Overview:

Address: 160 Baker Road Ext.

Original Construction: 1963

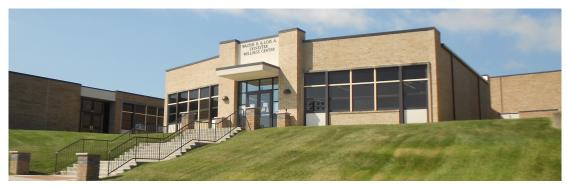
Exterior Walls: The exterior walls consist of brick veneer. Exterior walls are in good

condition. Some locations do appear to have minimal settlement and expansion cracks which are not structural in nature and can be

addressed through routine maintenance.

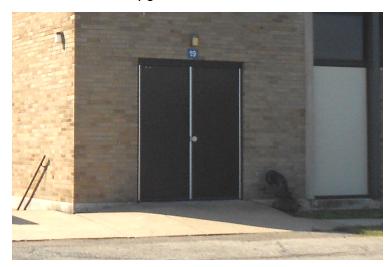
Exterior Doors:

- 1) The majority of the older hollow metal exterior doors and frames are in fair to poor condition, this excludes the areas renovated and constructed in the most recent renovations of 2006 & 2012/13.
- 2) Door hardware does not meet current accessibility standards.

Upgrades to both doors and hardware are recommended.

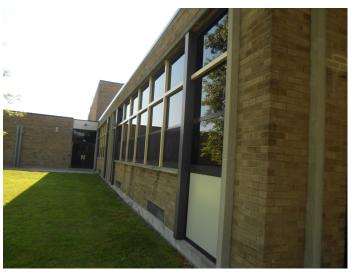
Windows:

Windows are single pane (non-insulated) excluding the most recent constructed areas which are small percentage of the building. Windows do not meet current energy code and window caulking is at the end of its life expectancy.

Replacement of the existing windows is recommended if a comprehensive renovation project would take place.

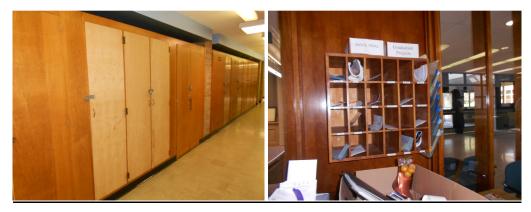
Casework: Casework and built-in furniture throughout the building is beyond its life expectancy. The majority of the building is original 1960's era equipment.

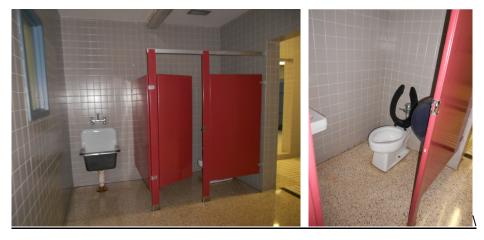
<u>Toilet Rooms:</u> Toilet rooms are original to the building. Tile should be upgraded. Toilet partitions and all plumbing fixtures should be replaced in their entirety.
