**SCHOOL: Todd Lane Elementary School**

**Overview:**

Address: 113 Todd Lane Road  
Monaca, PA 15061

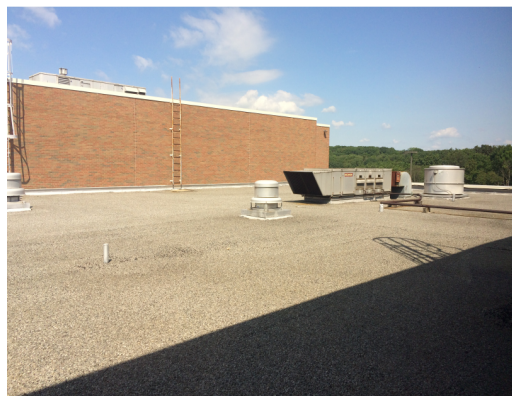
Roof System: The Roof is a Garland Modified Bituminous system, installed in the past 10-15 years, currently holding an R-20 insulation value. It is in good condition and carries a 30 year roof warranty, based on discussions with Garland Roofing.

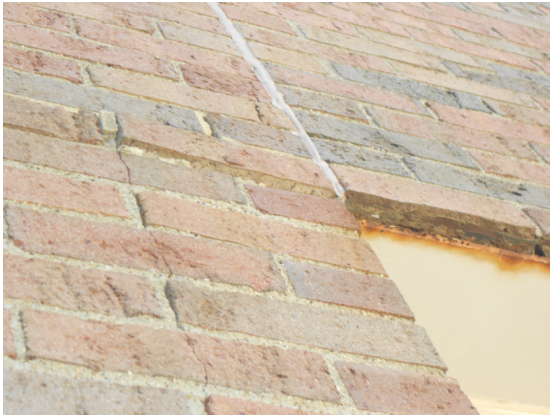
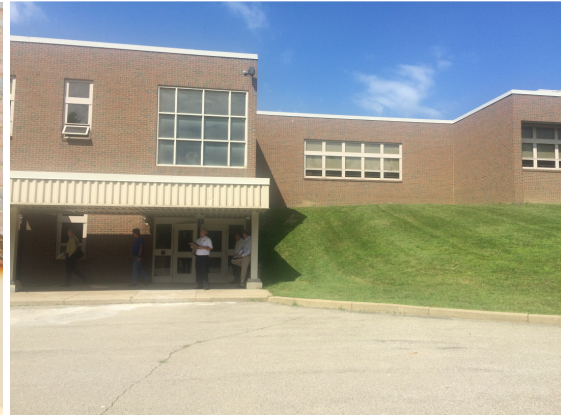
Exterior Walls: The exterior walls consist of brick veneer. Exterior walls are in fair to good condition. Expansion joints and caulking should be removed and replaced. It is anticipated they were last replaced as part of the 1995 renovation project.

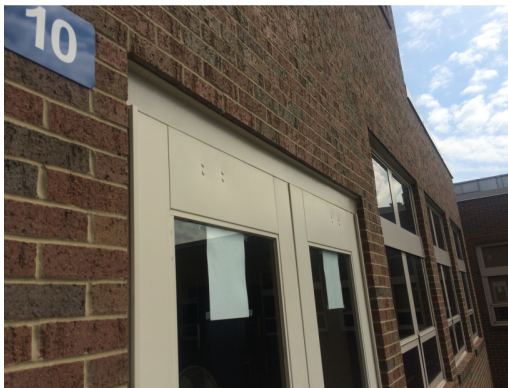
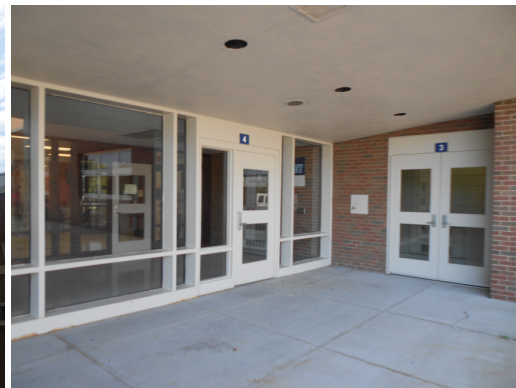
Exterior Doors: Appear to be in fair condition and appear to have been replaced as part of the 1995 renovation project. Caulking of doors should be redone, and security/ panic egress should be reviewed with school district due to amount of use for exterior doors.

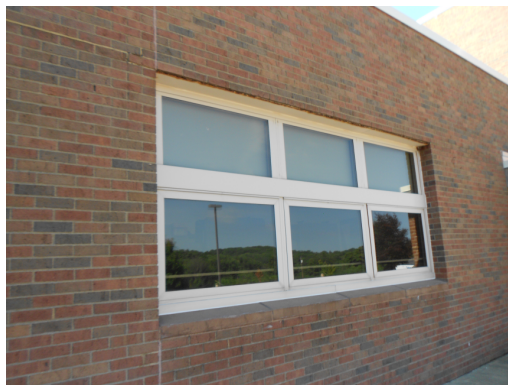
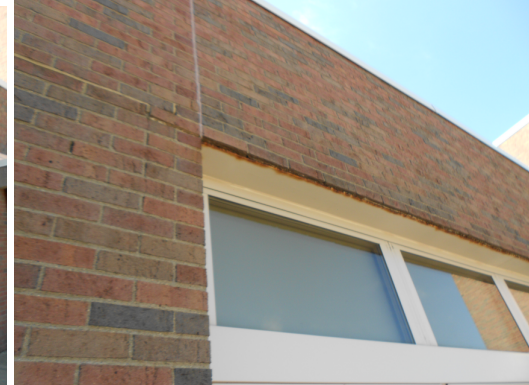
Windows: Windows should be replaced in their entirety. Steel lintels above windows are showing substantial signs of corrosion and rust. As part of a potential renovation project, it would be recommended to not only replace windows but address flashing systems within walls and window system. Water is infiltrating the buildings creating wall damage within classrooms.

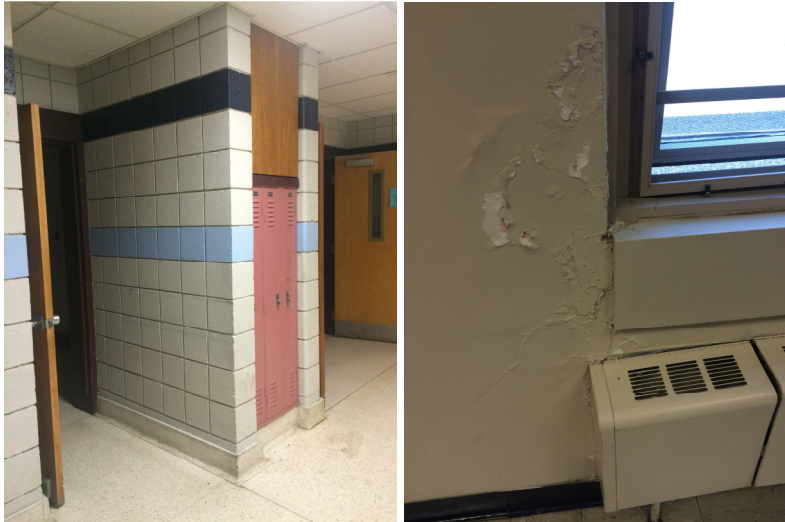
Interior Walls: Interior walls are painted concrete block, gypsum wall board and partition systems. Walls appear serviceable. There is substantial wall damage due to window leaks that should be addressed as soon as possible to minimize further damage to the building.

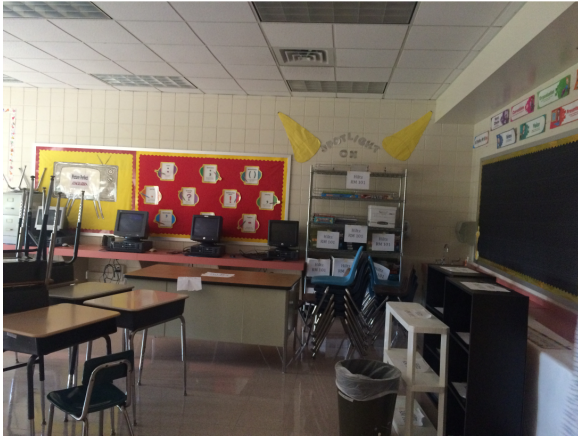
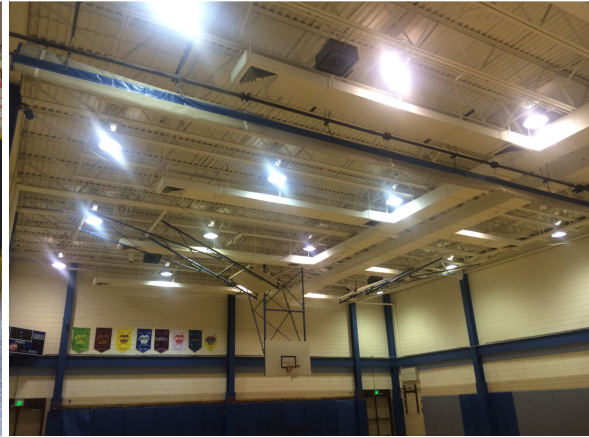
- Ceilings:
- 1) Acoustical tile ceiling systems are beyond their life expectancy and in poor condition throughout most of the building.
  - 2) Exposed roof deck in gyms appears to be in serviceable condition.

- 1) *Replacement of ceiling tile throughout the building is recommended. If a comprehensive renovation were to take place, the ceiling will need to be removed to upgrade mechanical systems requiring replacement at that time.*

*Exposed roof deck in gyms should be cleaned and repainted if a comprehensive renovation would take place.*

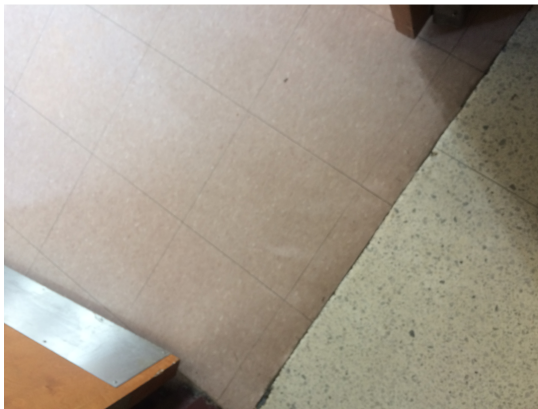
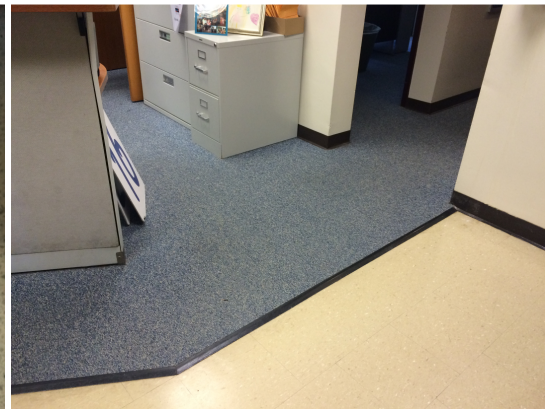
Flooring: Hallways are a combination of terrazzo and asbestos containing tile and vinyl composite tile (VCT) in Cafeteria and open hallway. Classrooms are both VCT and asbestos containing tile (ACT), predominantly based upon the 1971 and 1995 ages of construction for the building.

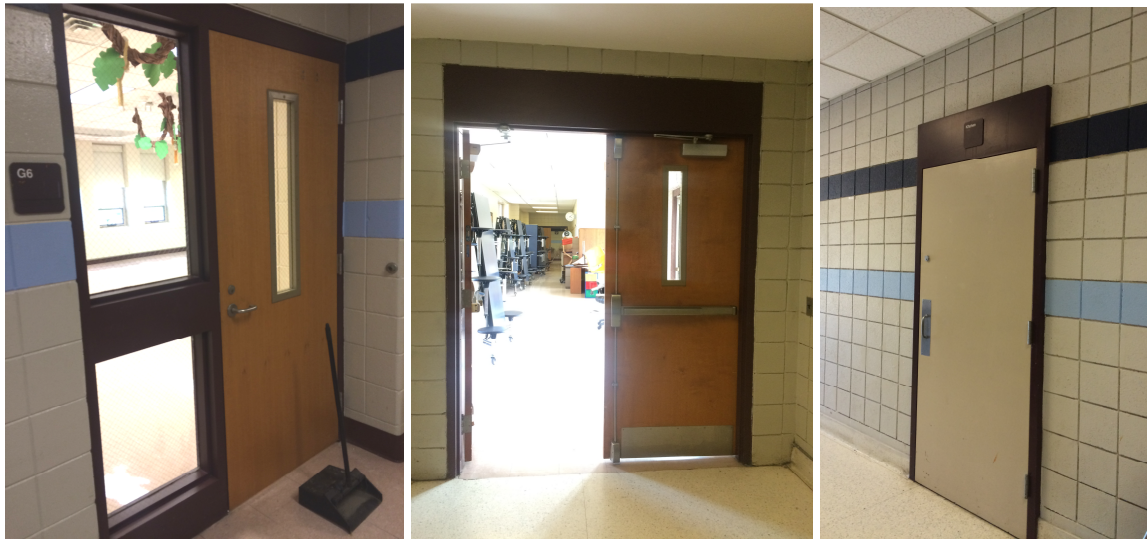
Doors: Doors are both 1971 and 1995 throughout the facility. Door hardware is typically not ADA code compliant and should be replaced if a renovation project would be contemplated.

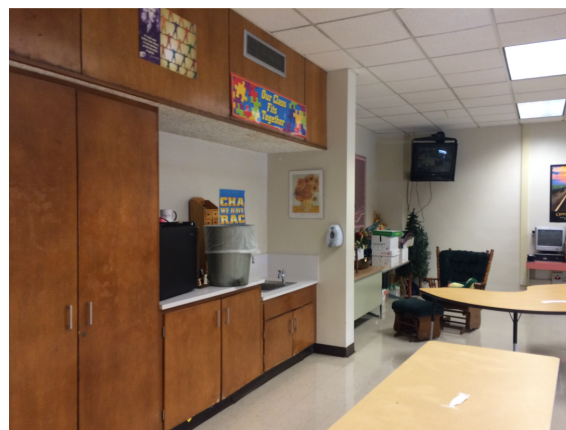
Casework: Casework and built-in furniture are 1971 and 1995 vintage. Replacement of casework throughout facility is recommended.

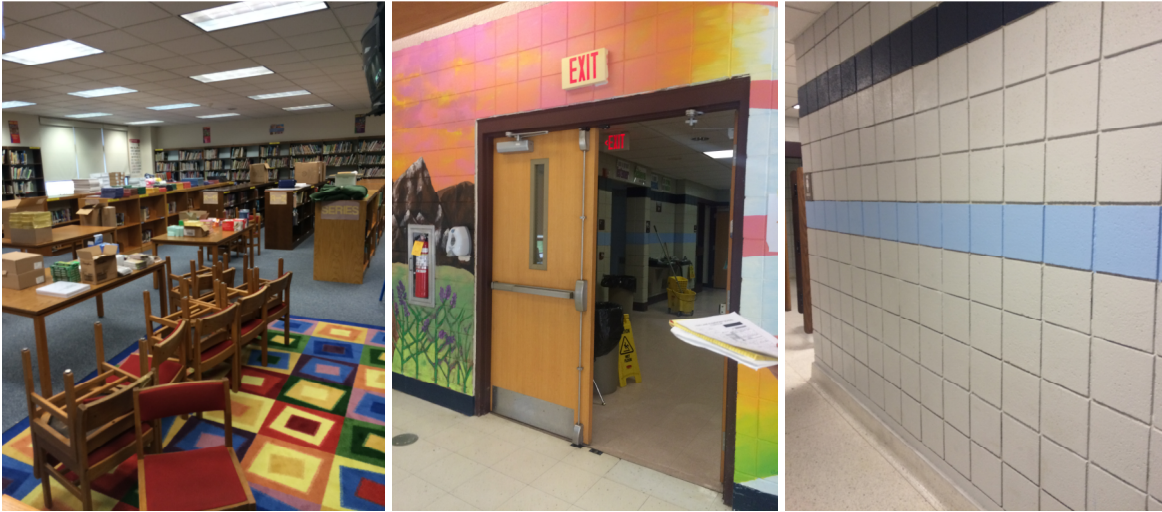
Interior Finishes: Interior finishes throughout the building are painted block and Gypsum wall board. They appear to be serviceable at this time.

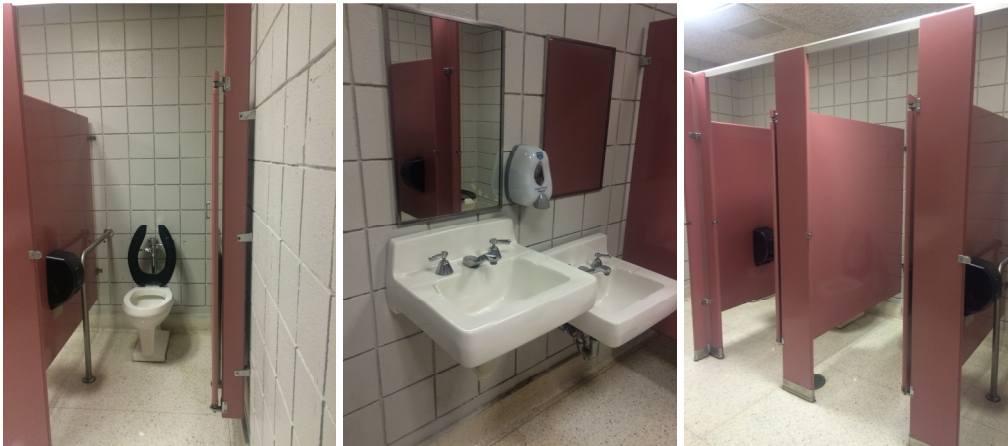
Toilet Rooms: Toilet rooms are original to 1971 & 1995 building; plumbing fixtures should be replaced in their entirety.

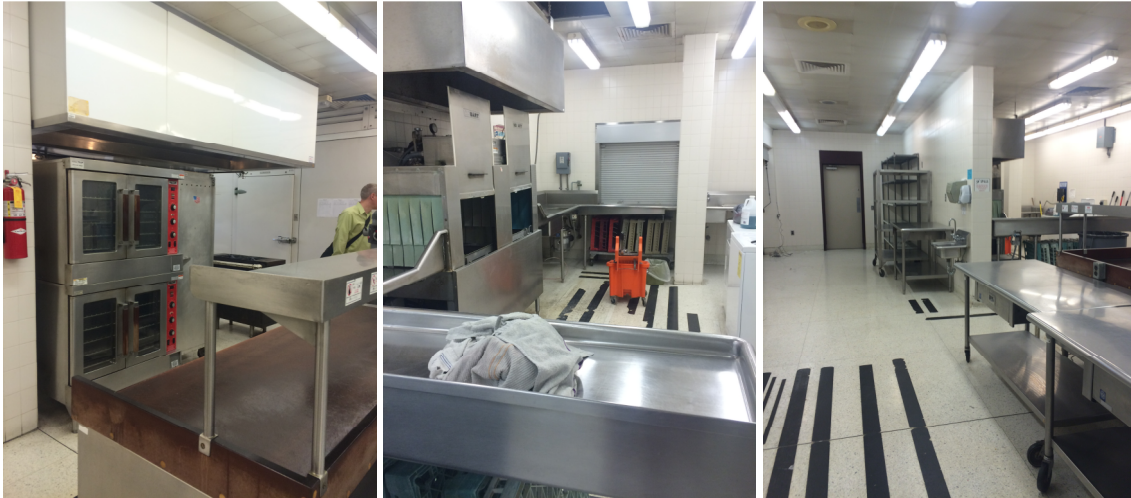
Kitchen Equipment: Kitchen equipment is in fair condition and has been well maintained over the life of the building. Food service designer has been contacted by architect and should complete full survey with staff. Largest concern is that kitchen is remote in the building from the current cafeteria requiring food to be brought down hallway daily to serving area that in the long term should be remediated.
