SCHOOL: Center Grange Primary School

Overview:

Address: 225 Center Grange Road
Monaca, PA 15061

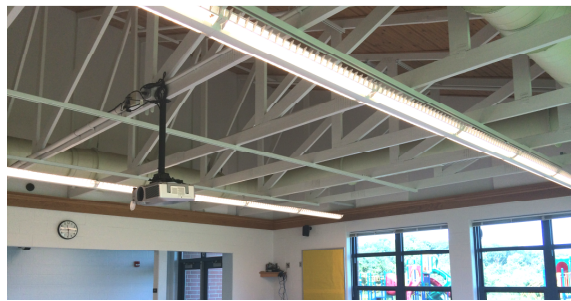
Structural System: Structural system is typically load bearing masonry and steel frame walls with metal roof structure and deck. Limited wood joist and wood deck is utilized as accent material in exposed Large Group Instruction areas. All structure appears to be in excellent condition.

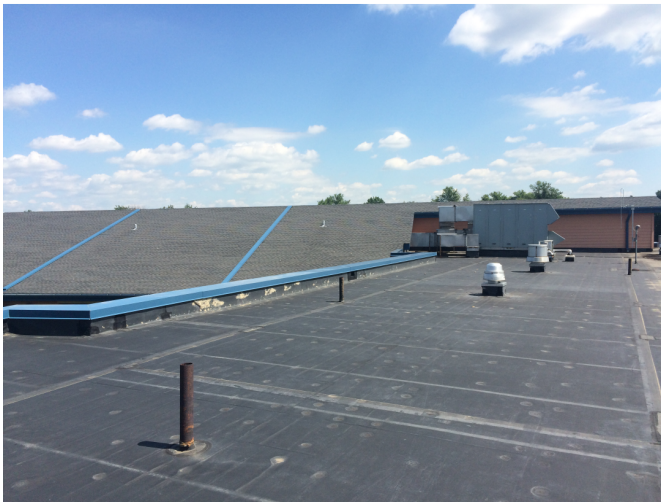
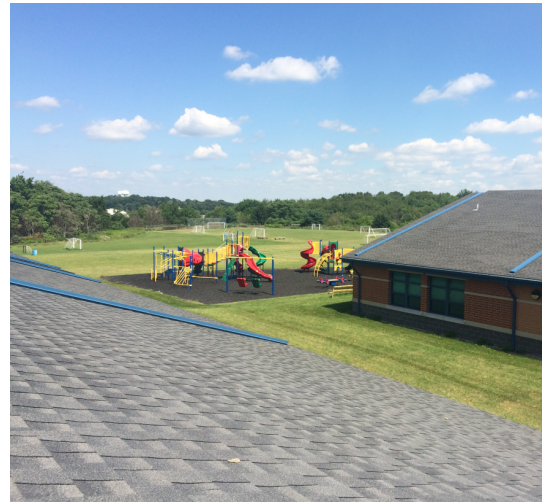
Roof System: Roof is in excellent condition and is predominantly low slope EPDM rubber for the main body of the building including public spaces. Classroom wings are sloped roof with asphalt shingles which also appear to be in good condition.

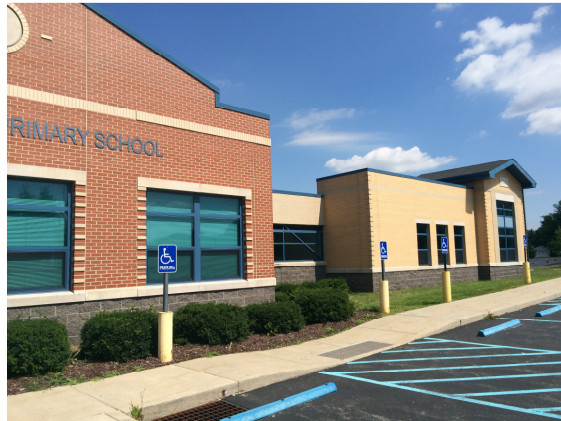
Exterior Walls: Exterior walls are predominantly brick and split face concrete block. Accents of precast concrete are utilized around windows. Roof top walls, not easily accessed, are utilizing concrete siding. Masonry materials are in excellent condition. Concrete siding is

experiencing weathering after 8-9 years. District should plan painting schedule for siding which is typically recommended to be cleaned and painted every 10-15 years.

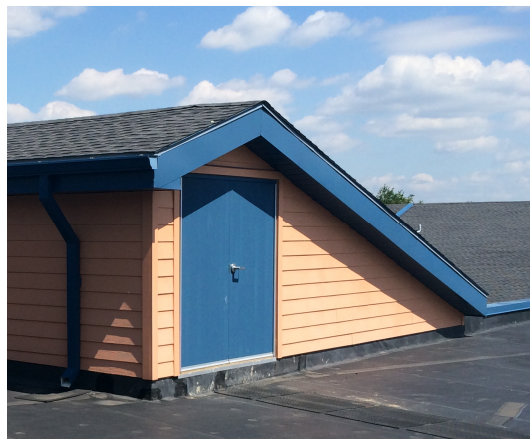
Exterior Doors: Exterior doors are a combination of solid hollow metal doors and aluminum storefront windows at public and student access doors. All are in excellent condition. Routine maintenance should be anticipated.

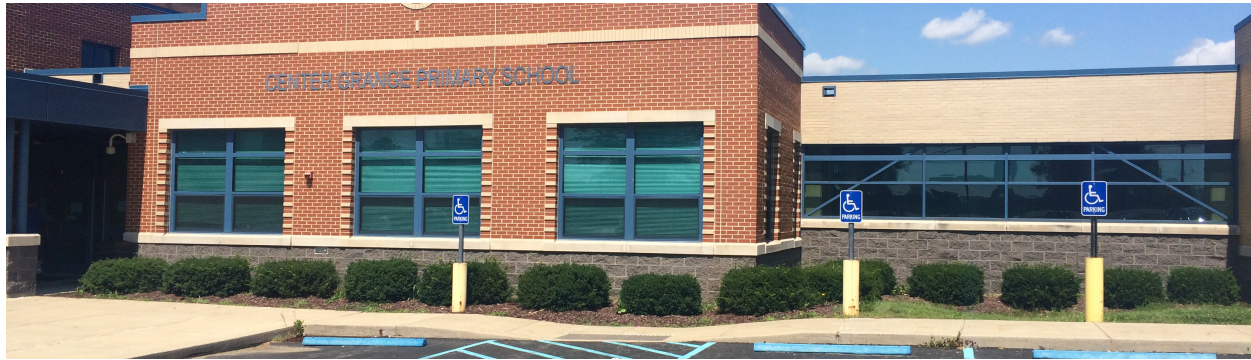
Windows: Windows are double glazed insulated aluminum storefront systems and are in excellent condition. Routine maintenance should be anticipated.

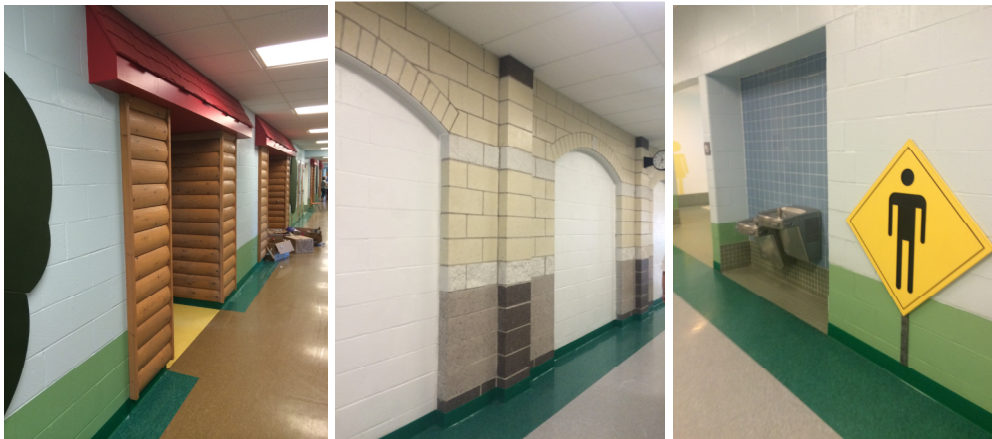
Interior Walls: Interior walls range from a variety of materials, but are generally concrete masonry units with applied finish materials. All are in excellent condition. Routine maintenance should be anticipated.

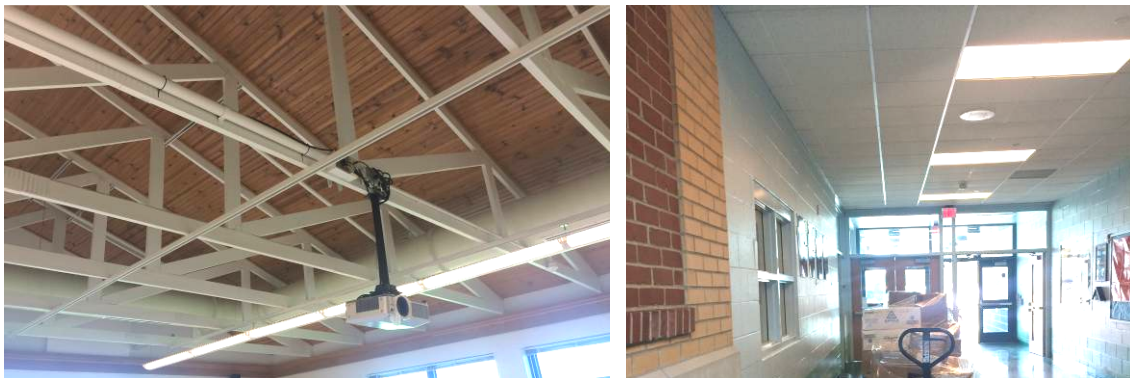
Ceilings: Ceiling materials include acoustical tile ceilings and exposed roof deck. Large Group Instructions are exposed wood trusses with wood attached to the underside of the roof deck. All are in excellent condition. Routine maintenance should be anticipated.

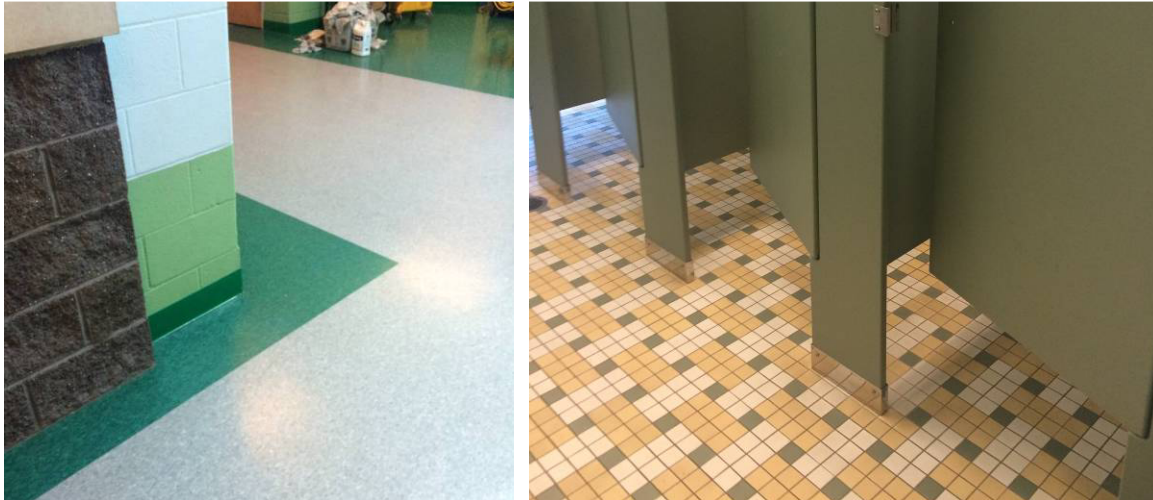
Flooring: Flooring materials consist of VCT throughout, with the exception of carpet in the Media Center and porcelain tile in the toilet rooms. All are in excellent condition. Routine maintenance should be anticipated.

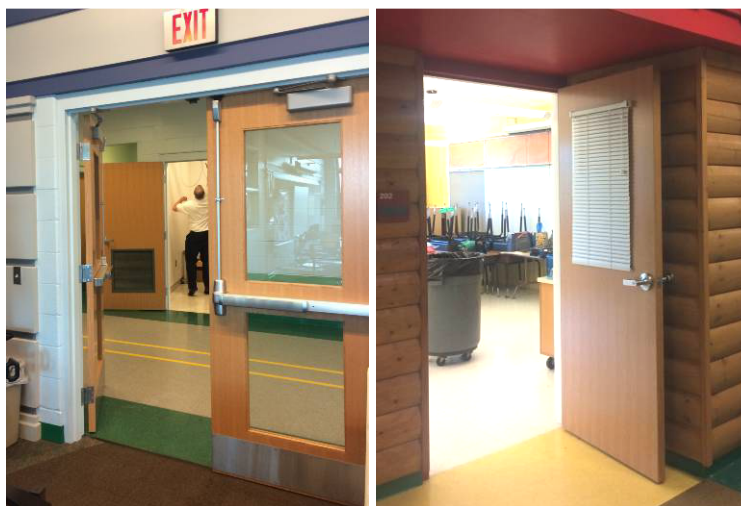
Doors: Interior doors are wood with hollow metal/aluminum frames and are in excellent condition. Routine maintenance should be anticipated.

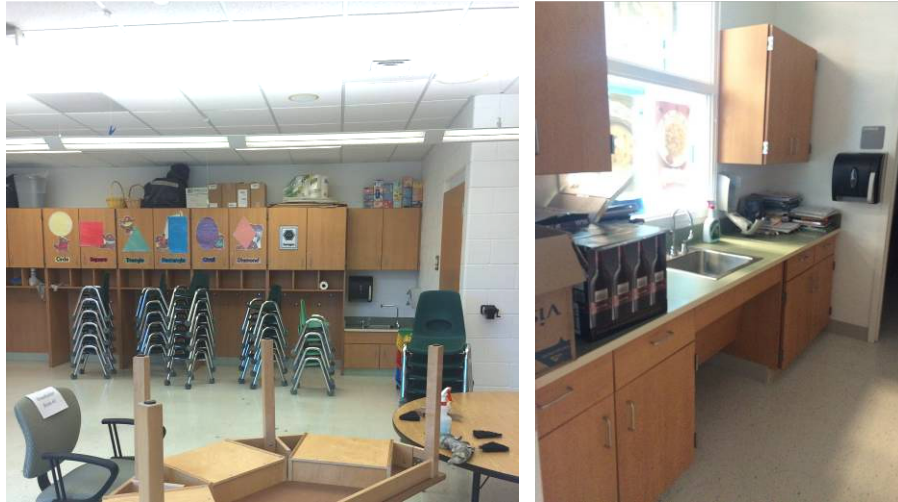
Casework: Built-in casework in classrooms is in excellent condition. Routine maintenance should be anticipated.

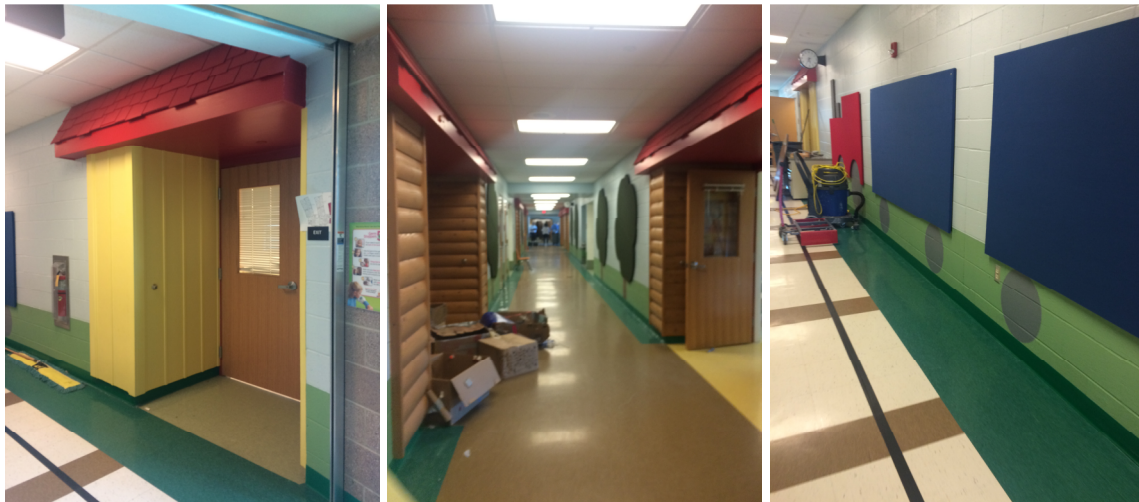
Interior Finishes: Interior finishes throughout the facility are typically painted concrete block walls with accents of wood and concrete siding painted and constructed to create themes throughout the building. All finishes appear to be in excellent condition. The one exception are tack boards which have periodically delaminated from walls and have been reattached by staff. Routine maintenance and yearly painting during summer months appears to be occurring.

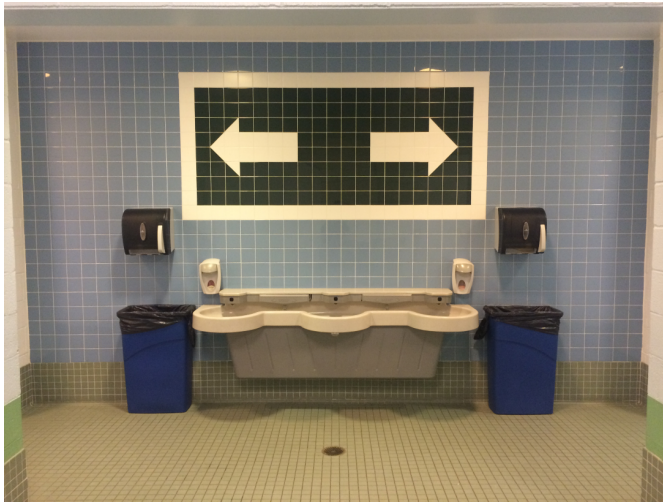
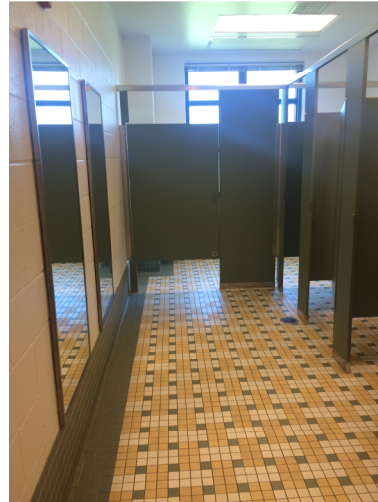
Toilet Rooms: Toilet rooms are in excellent condition. Routine maintenance is occurring and no further recommendation is required at this time.
