## ALLEGHENY MOUNTAIN RESEARCH, INC.

Re: Indoor Air Quality (IAQ)/dust composition testing study

Enclosed please find sampling data, laboratory results and monitoring conclusions from an IAQ/dust composition testing study conducted on November 29 and 30, 2017 @ Todd Lane Elementary School, 113 Todd Lane, Monaca, PA. This study was completed to determine various material concentrations in collected air and dust samples. There has been an on-going construction project @ the school and staff/students continue to occupy a portion of the building. Where applicable, the testing/sampling results shall be compared to existing Federal exposure limits to determine if there is a staff/student exposure issue from any of the tested/sampled materials.

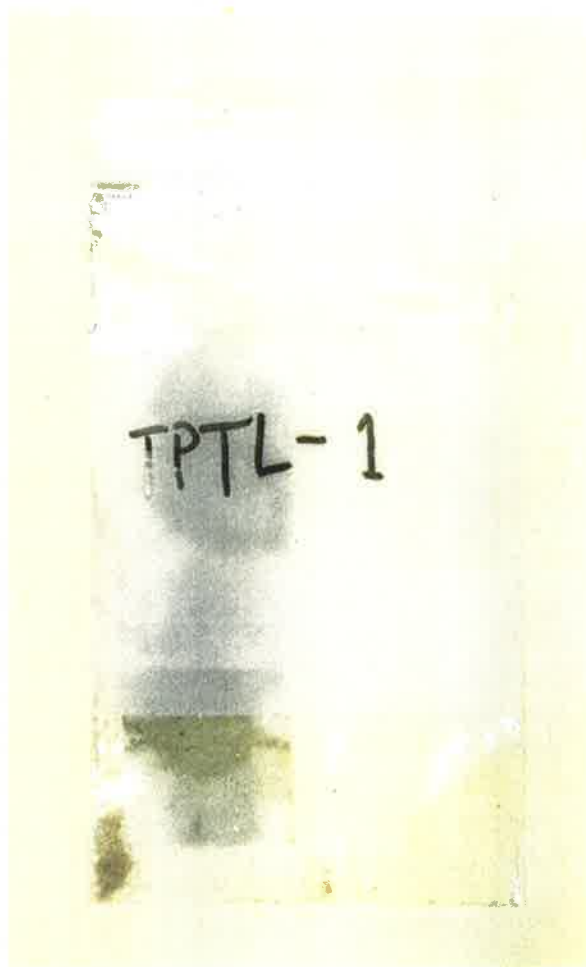
Figure 1: One wipe sample (TPTL-1) as received for analysis.

The wipe sample was initially analyzed in its as-received condition. The wipe material was then sonicated in 2-propanol and the resulting suspension filtered through a 0.45 $\mu$ m mixed cellulose ester filter in order to collect the fine particles for further analysis.

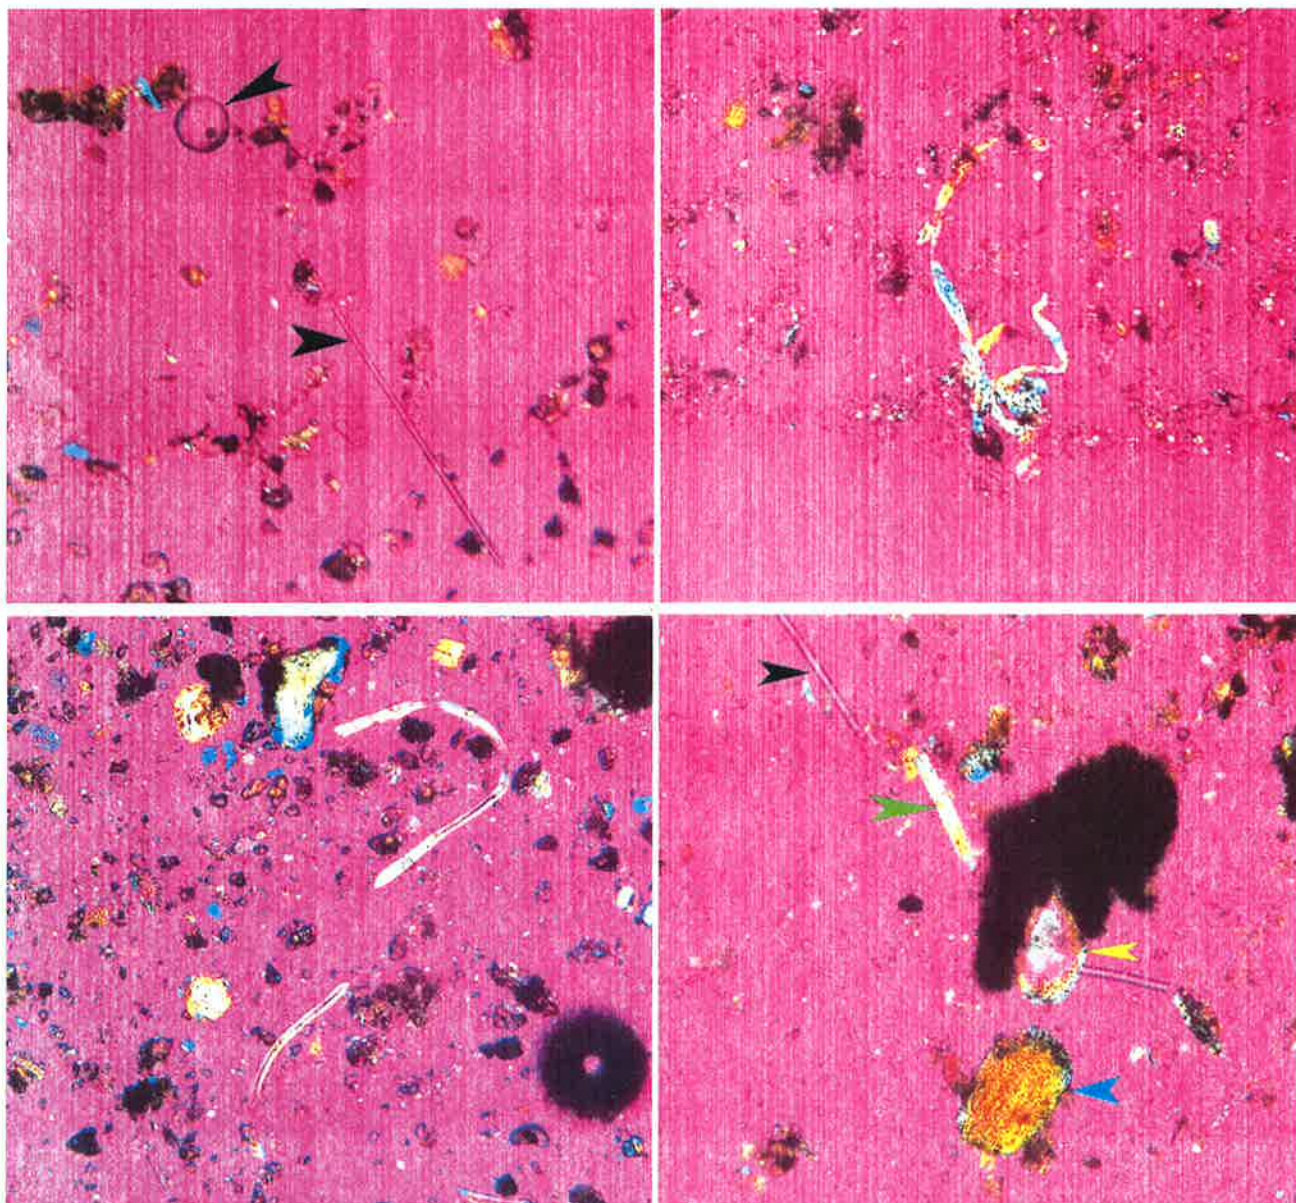
Figure 2: PLM images of material from sample TPTL-1 showing a mixture of quartz (yellow arrow), calcite, feldspar (blue arrow), gypsum, fibrous glass (black arrow) and natural plant matter (green arrow).

The data indicates that the sample is predominantly composed of building dust including quartz and calcite consistent with concrete dust and gypsum from wallboards and joint compounds. Lesser amounts of insulation fibers (fibrous glass and mineral wool) were also observed. The sample also contains particles consistent with outdoors environmental contaminants (natural plant matter).

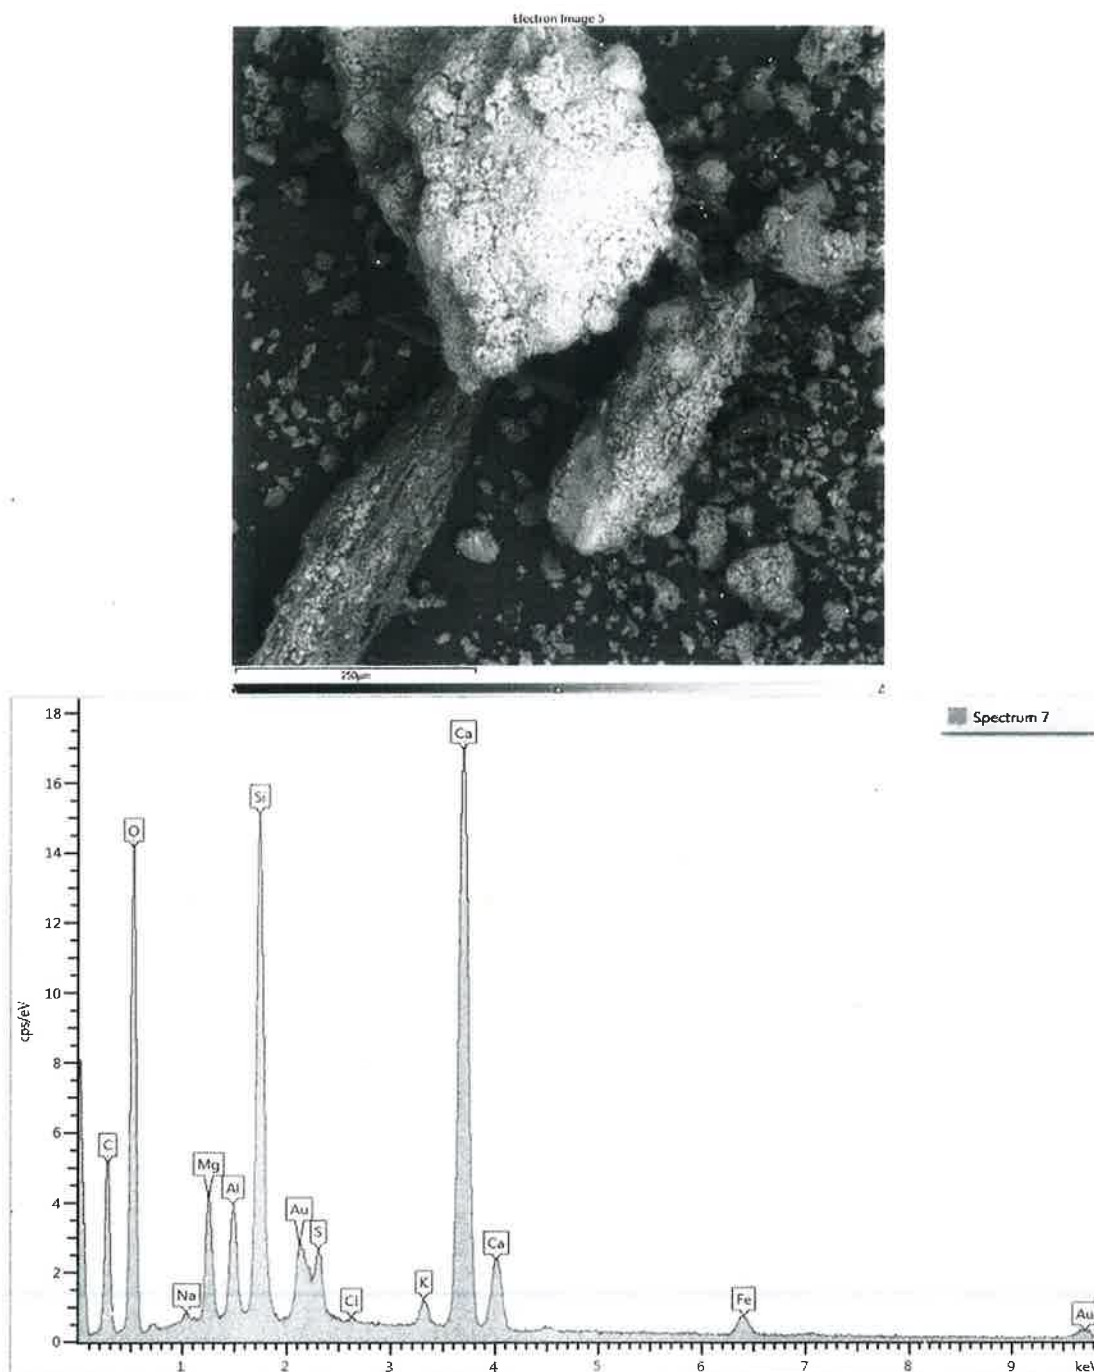
Figure 3: SEM image and associated EDX spectrum showing the elemental composition of material from sample TPTL-1 (elements associated with calcite, quartz, feldspars, and gypsum as primary components).

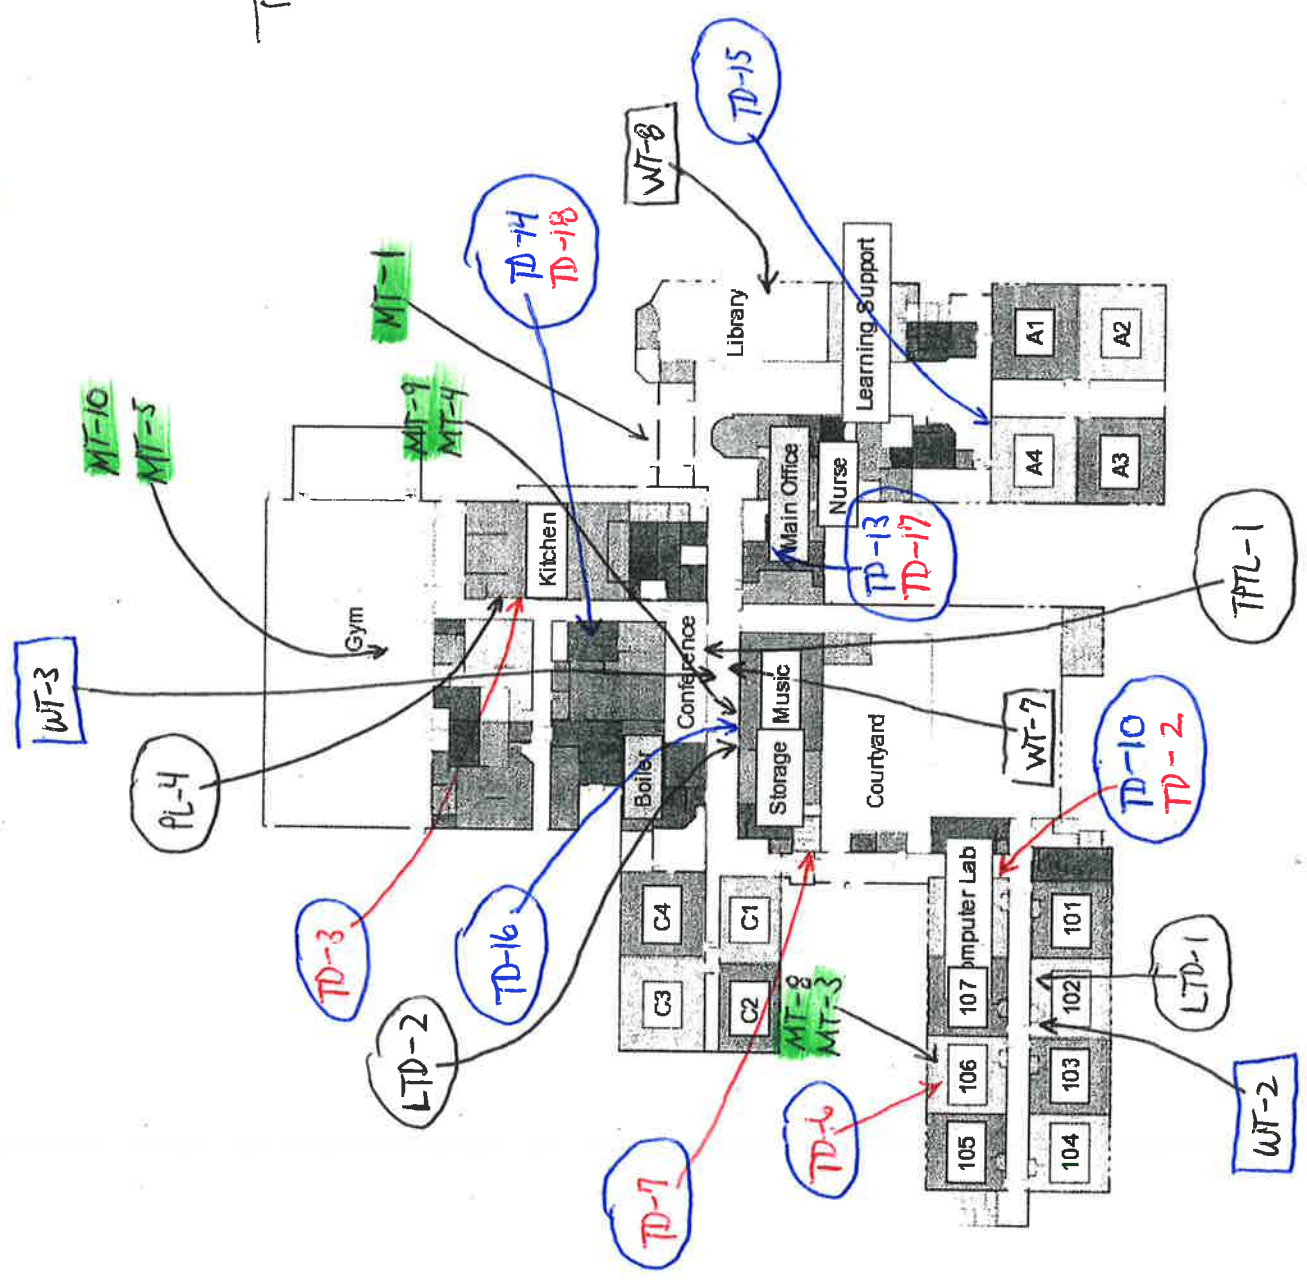
Todd Lane  
 1st Floor

• = Resp. dust / silica  
 • = Total dust  
 • = Mold

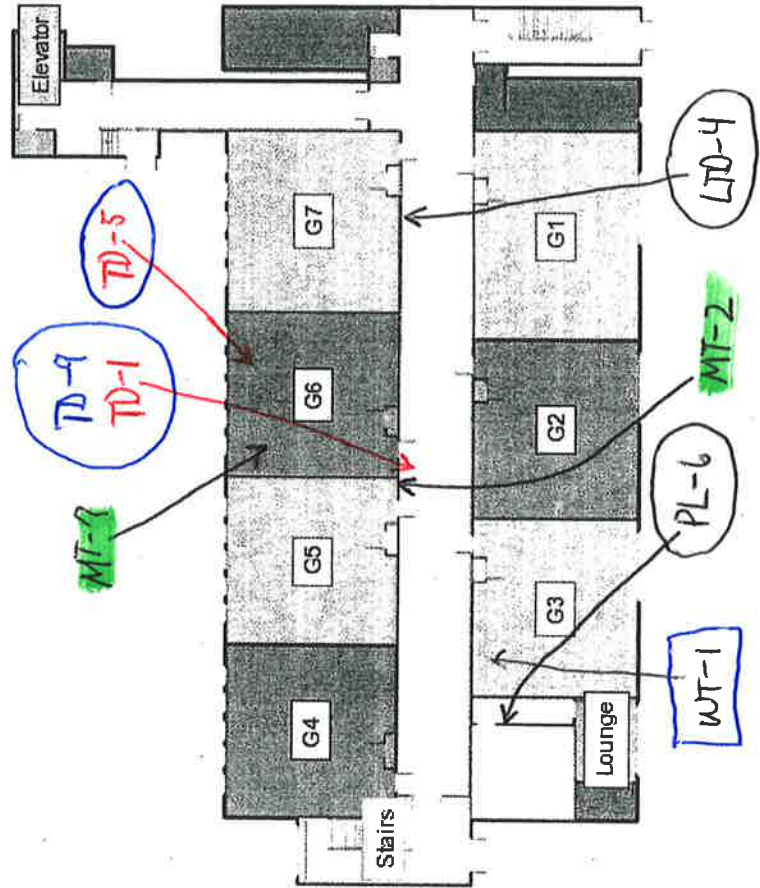
Todd Lane  
Basement

- = Resp. dust / silica
- = Total dust
- = Mold
