## **INDOOR AIR QUALITY AND DUST ASSESSMENT REPORT**

**INCLUDING RESPIRABLE/TOTAL DUST, SILICA, MOLD, FIBERS, METALS, VOCs, PCBs,  
CO, COMFORT PARAMETERS, and LEAD-IN-WATER**

**Project # 172462**

**Todd Lane Elementary School  
113 Todd Lane  
Monaca, PA 15061**

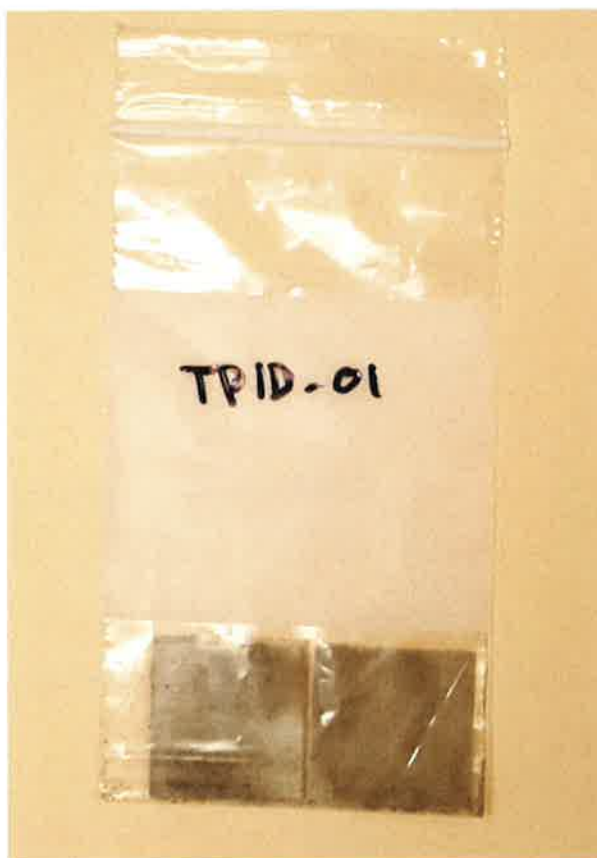
Figure 1: One wipe sample (TPID-01) as received for analysis.
